Tornado Protection

Selecting Refuge Areas in Buildings

Florida Department of Community Affairs
Tallahassee, FL 32399-2100

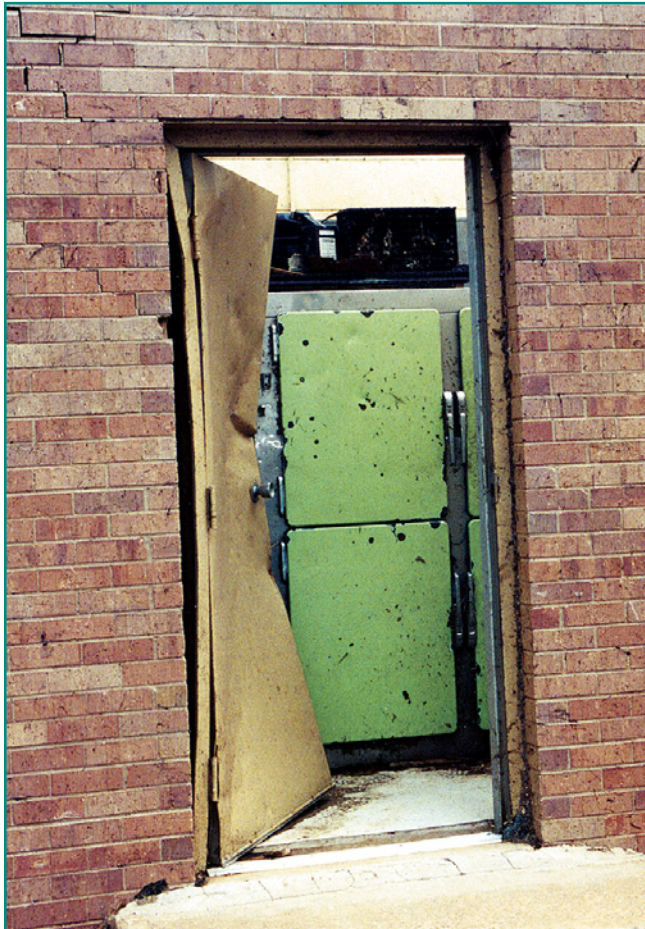
Figure 2-2

Example of damage from a windborne missile. A 2-inch by 6-inch board penetrated a refrigerator.

The extreme winds in tornadoes pick up and carry debris from damaged buildings and objects located in the path of the winds (see Figures 2-2 and 2-3). Even heavy, massive objects such as cars, tractor trailers, and buses can be moved by extreme winds and cause collateral damage to buildings. Light objects become flying debris, or missiles, that can penetrate doors, walls, and roofs; heavier objects can roll and cause crushing-type damage.

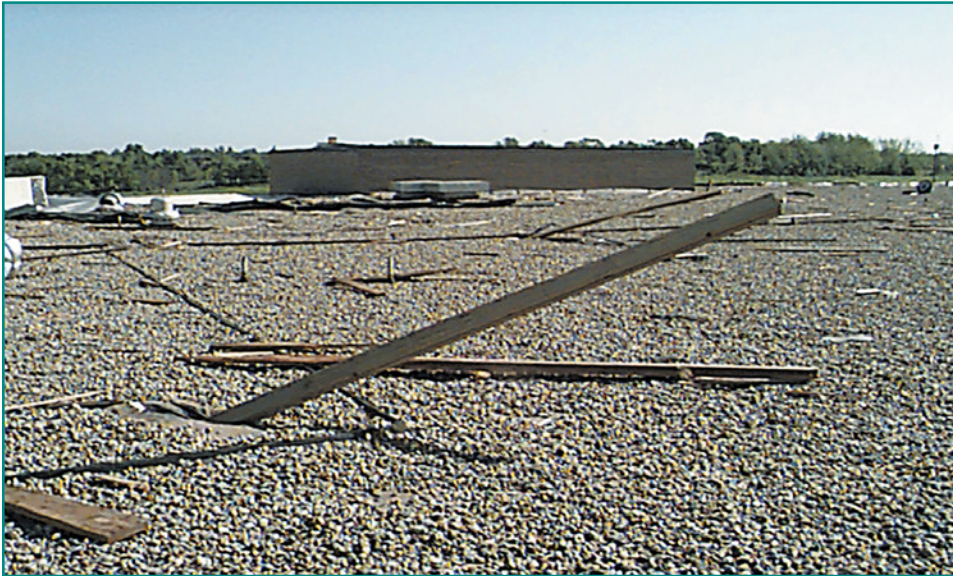
Figure 2-4

Example of damage from windborne missiles. Medium and small missiles penetrating through the roof of a high school. The missile protruding from the roof in the foreground is a double 2-inch by 6-inch wood board. The portion sticking out of the roof is 13 feet long. This missile penetrated a ballasted ethylene propylene diene monomer (EPDM) membrane, approximately 3 inches of polyisocyanurate roof insulation, and the steel roof deck. The missile lying on the roof just beyond it is a 2-inch by 10-inch, 16-foot-long wood board. The missile protruding from the roof in the background is a 2-inch by 6-inch, 16-foot-long wood board.

Missiles can travel vertically as well as horizontally (see Figure 2-4). Therefore, shelters and refuge areas should provide protection overhead as well as on the side. Building walls and roofs can be designed to withstand the impacts of these missiles. Protection can be provided at the exterior building wall, or interior barriers can be constructed to provide protection for a smaller area within the building.

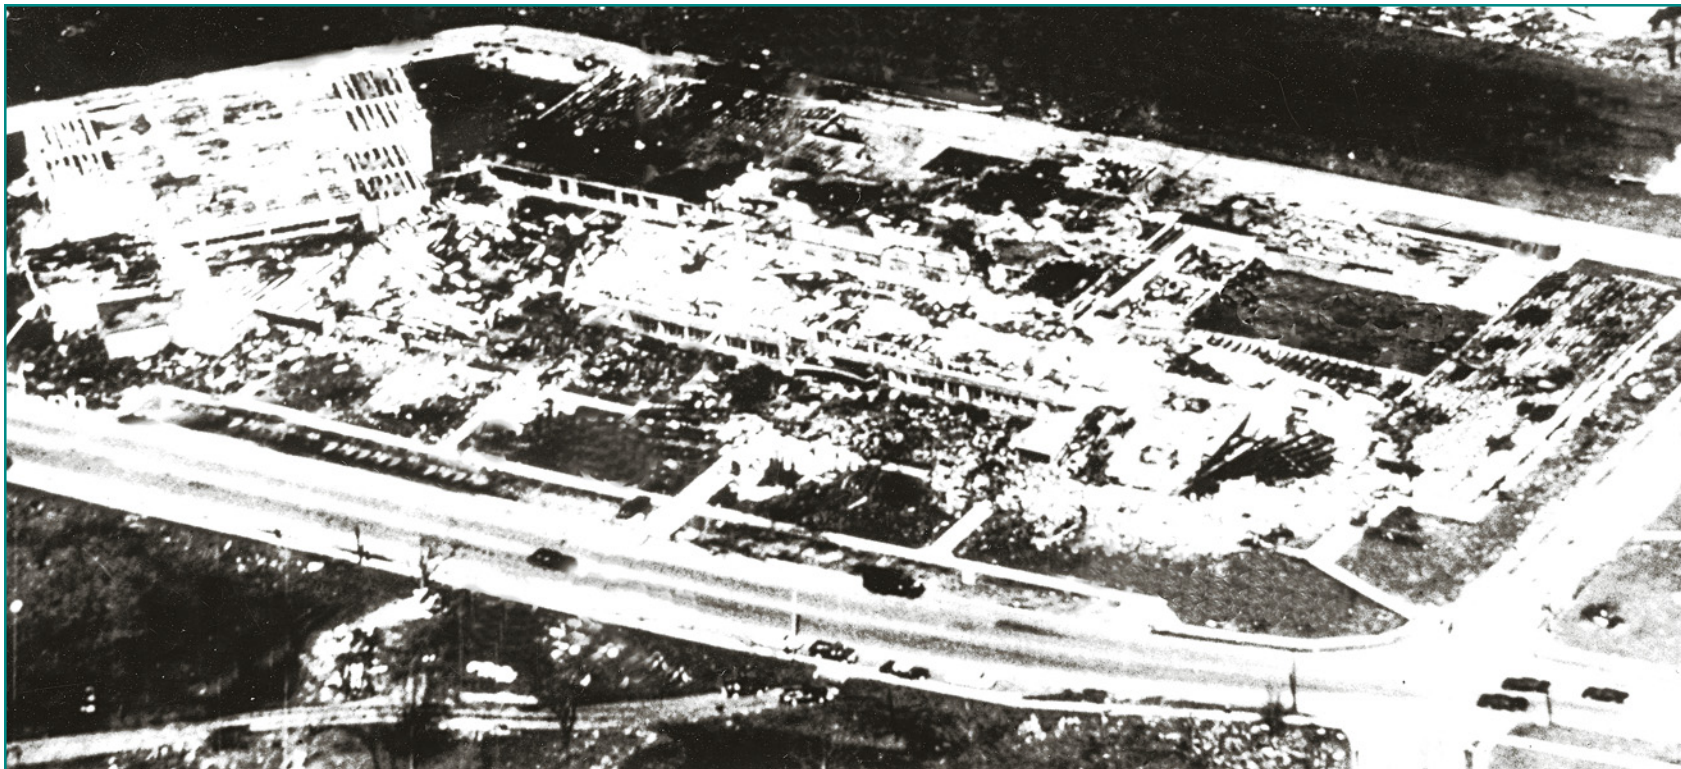
Figure 3-2 Xenia Senior High School, Xenia, Ohio.

The enclosure walls failed on the west and south sides, allowing the winds to enter the building. The roofs collapsed over the three large spans—the auditorium, the boys' gym, and the girls' gym. The lightweight roof over the original two-story building was torn off by the extreme winds.

All **windows** on the west and south sides were blown into the interior. The high single-story, **loadbearing masonry walls** of the **long-span** rooms failed, allowing the roofs to fall in. The unbaffled west entrances allowed the east-west corridors to become **wind tunnels**.

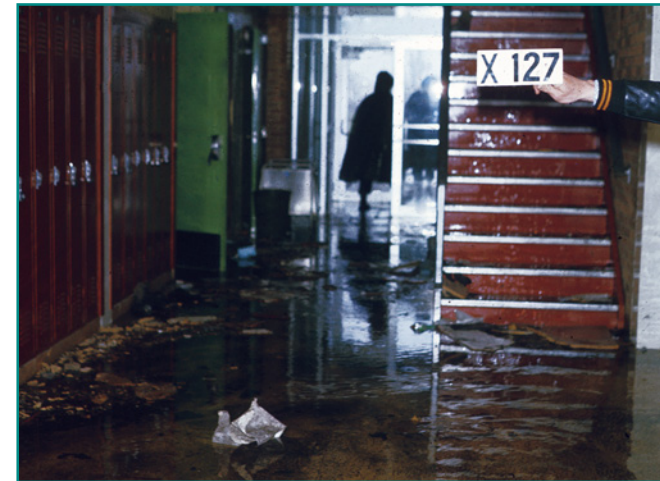
Figure 3-3
Surviving interior hallway. This is an example of the type of area that may provide refuge for building occupants during a tornado.

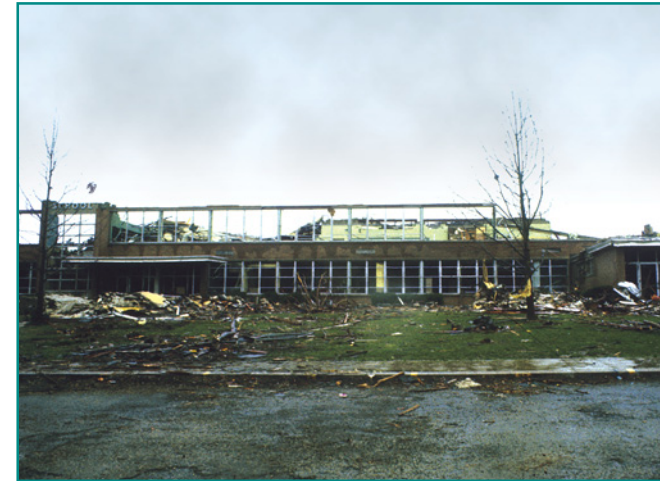
Figure 3-5
Loss of lightweight roof over the original two-story building.

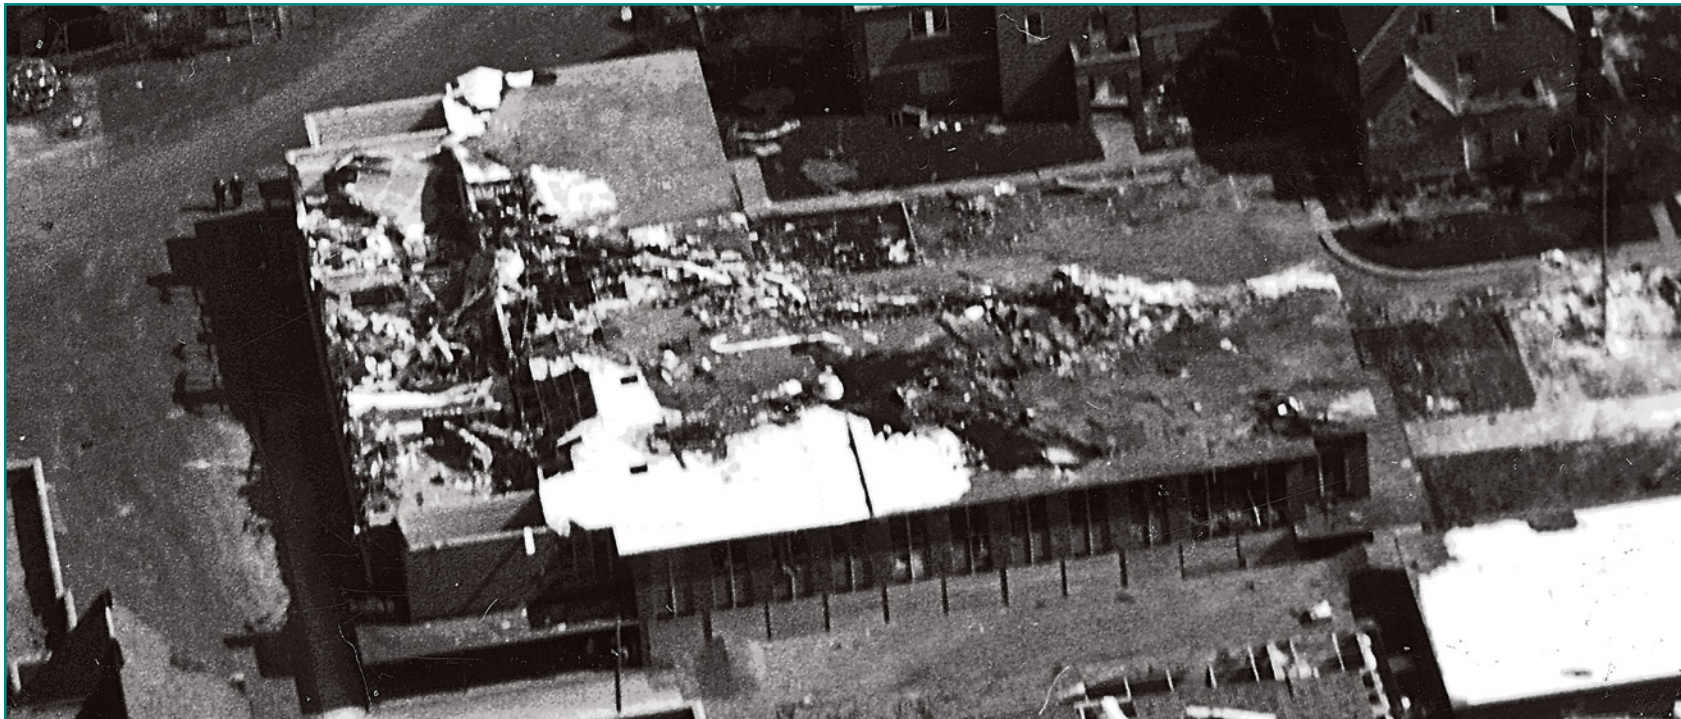
Figure 3-8 St. Augustine Elementary School, Kalamazoo, Michigan.

The tornado winds lifted part of the roof and collapsed the second-floor piers in one wing of the school building (Figures 3-8, 3-9, and 3-10). The wind and windborne debris blew in most of the windows, and windborne debris was found in the classrooms (Figure 3-11). The exterior solid-core wood doors stayed in place and kept the debris out. Wired glass windows near the exterior doors remained intact. The interior doors to the classrooms remained in place although the hinges were damaged. The school was damaged to an extent where demolition was required.

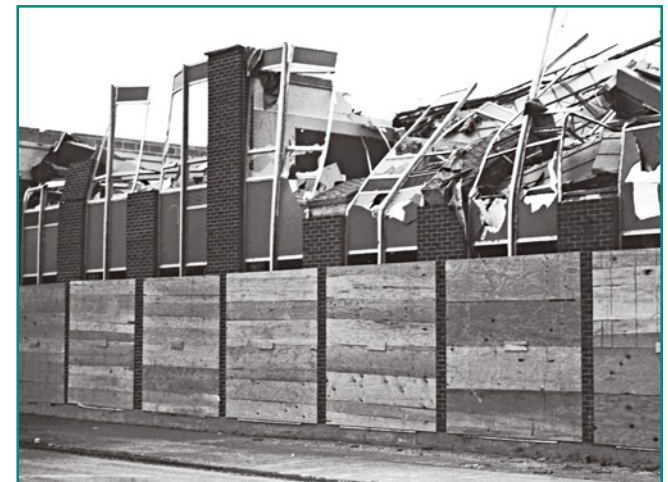
Figure 3-9
Collapsed second floor of St. Augustine Elementary School building.

The structural system of **unreinforced masonry piers** collapsed and almost one-third of the second-floor **lightweight roof structure** was lifted. Roof removal occurred over the classrooms as well as over the corridor. Most of the **skylights** in the corridors were removed by wind or broken by windborne debris. Almost all the **windows** on both floors were broken. Windborne debris and broken glass were found in the classrooms.

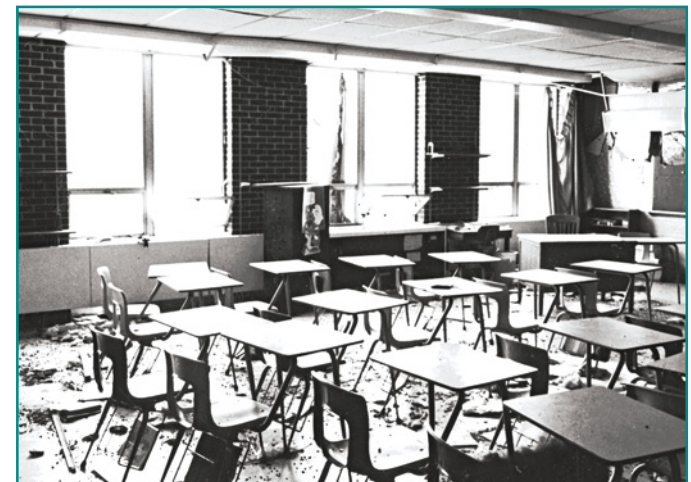
Figure 3-11
Broken windows and debris in classroom of St. Augustine Elementary School building.

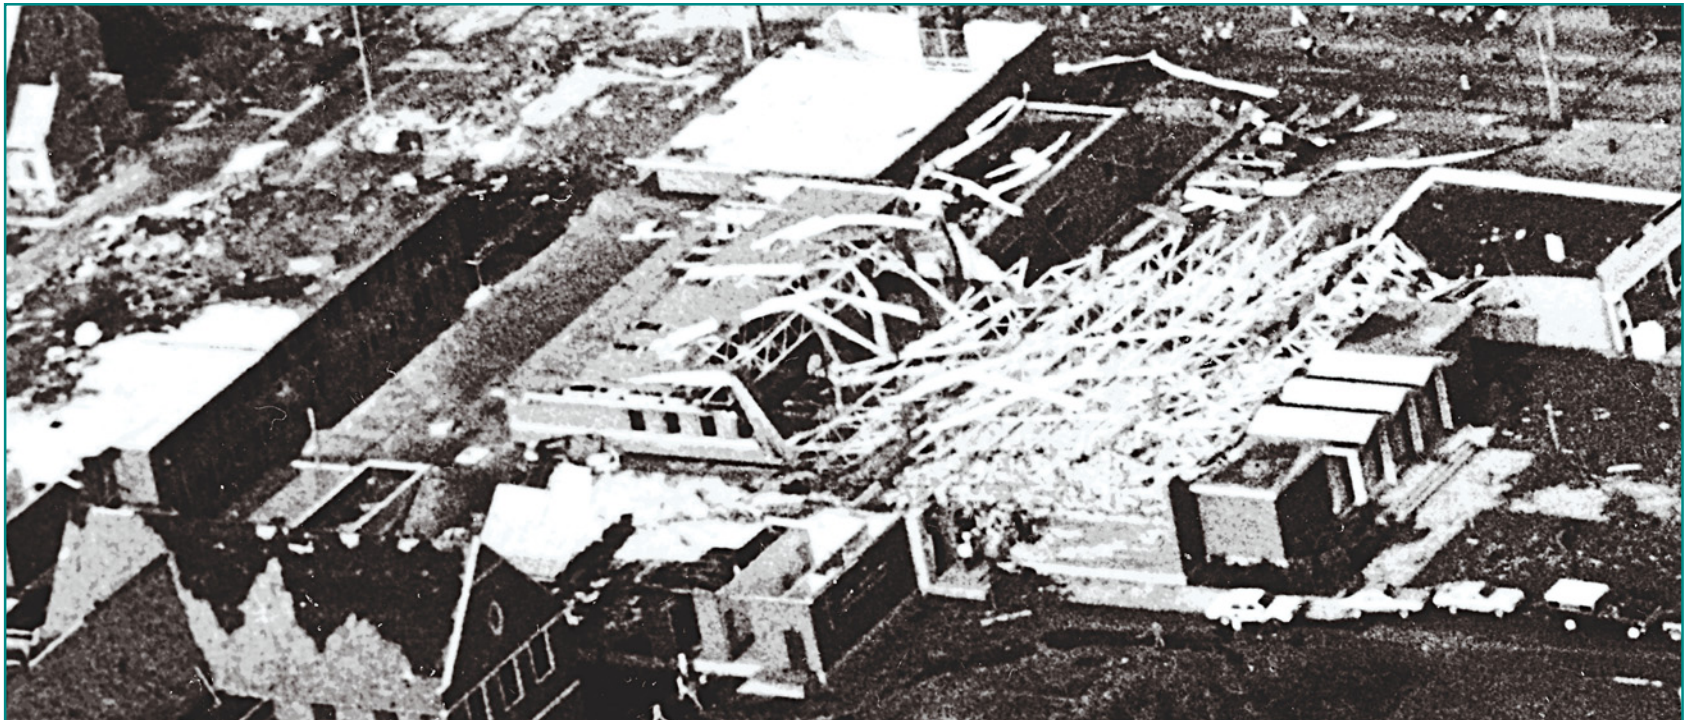
Figure 3-13 St. Augustine Elementary School Gymnasium, Kalamazoo, Michigan.

The structural system consisted of loadbearing masonry walls constructed of 12-inch concrete masonry units and 4-inch face brick. The walls were not re-inforced in the vertical direction. The roof structure consisted of long-span steel joists spanning 80 feet between the walls and spaced 6 feet apart. The steel roof deck was connected to the joists with puddle welds.

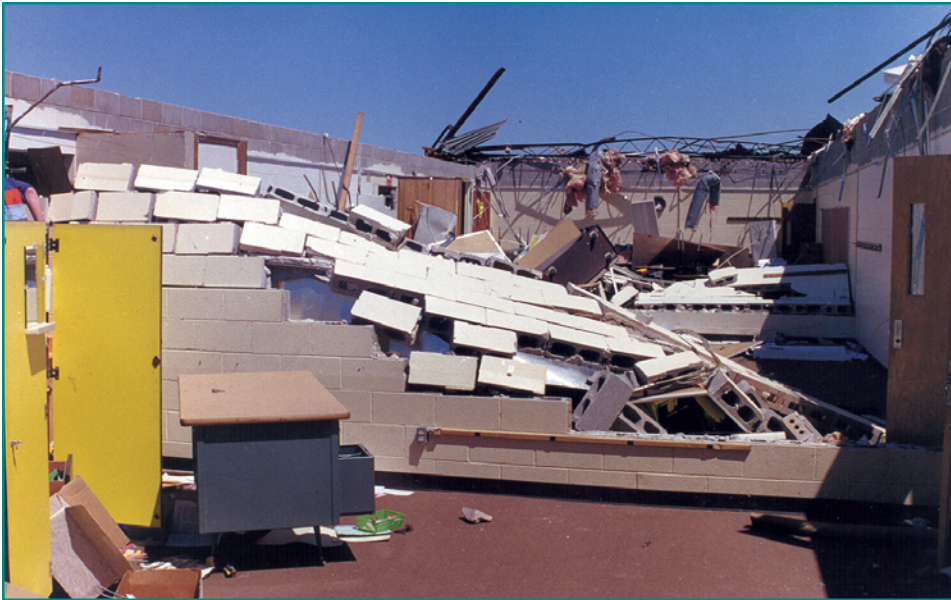
Figure 3-17
Interior and exterior unreinforced masonry walls were damaged when reinforced bond beams failed.

Unreinforced masonry walls failed when the roof system was lifted or removed by tornado winds (Figures 3-17, 3-18, and 3-19). Figures 3-17 and 3-19 show failed interior and exterior walls, respectively. Figure 3-18 shows the separation of the reinforced bond beam (indicated by circles) from the upper part of a corridor wall. The inclusion of clerestory windows in some corridor walls contributed to their failure under loads imposed by tornado winds (Figure 3-20).

Unreinforced masonry walls failed when the reinforced bond beams at the tops of the walls failed.

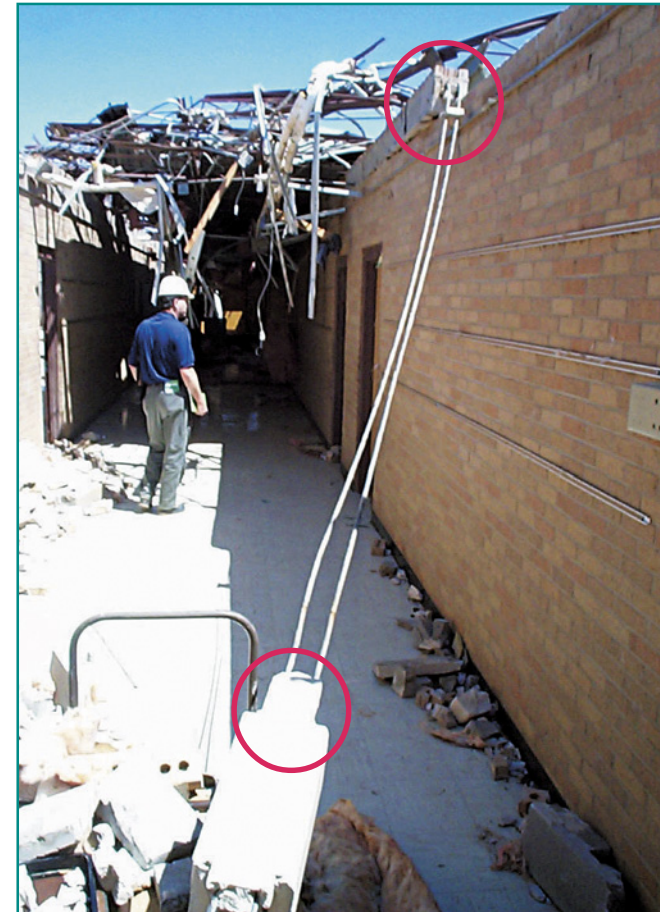
Figure 3-18
Corridor area. Separation of reinforced bond beam (indicated by circles) from supporting wall.

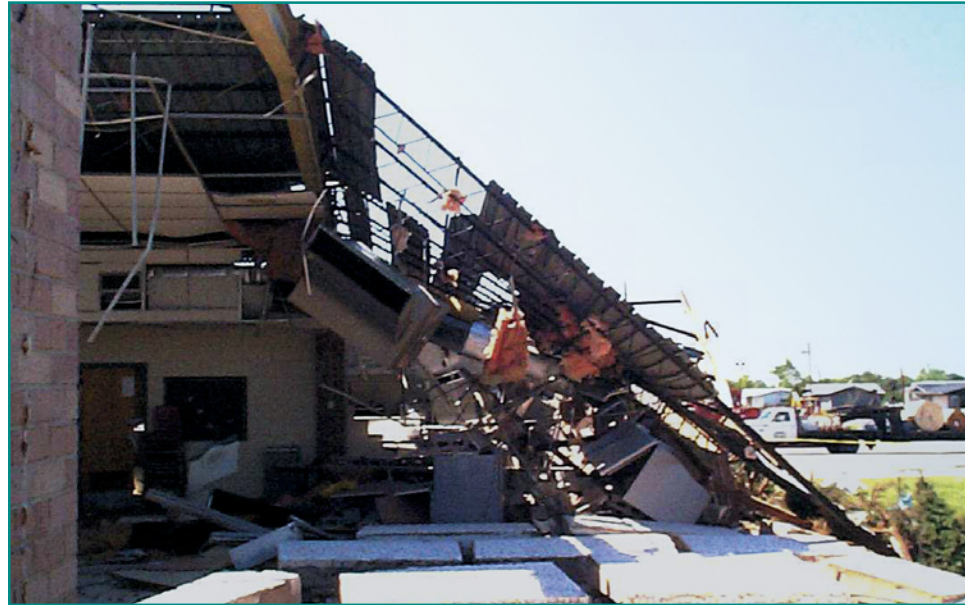
Collapsed roof structure and exterior wall.

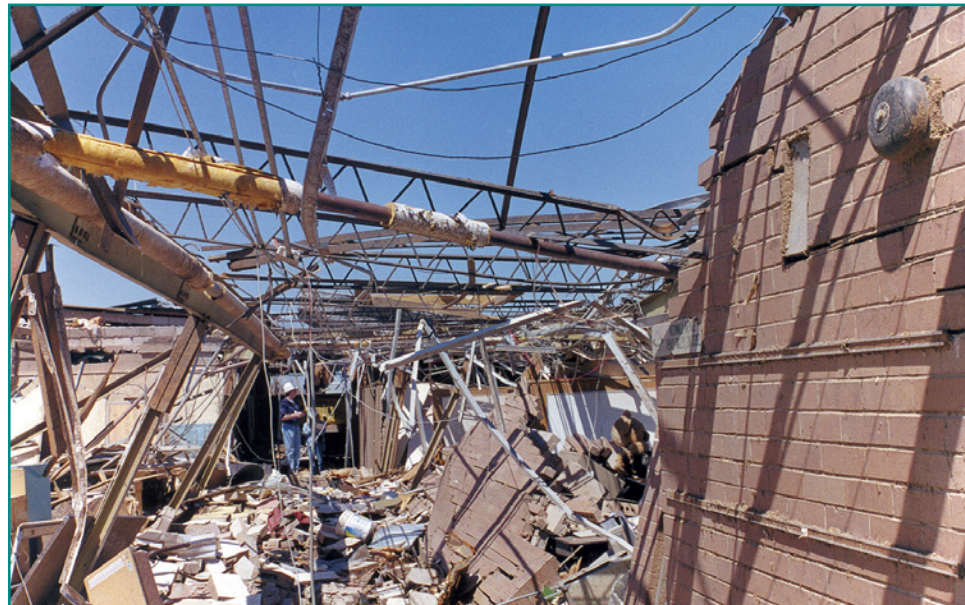
Failed interior corridor walls. These walls consisted of unreinforced brick masonry infill between steel-frame members. The brick masonry extended to a height of approximately 7 feet. Clerestory windows extended from the top of the masonry to the tops of the walls.

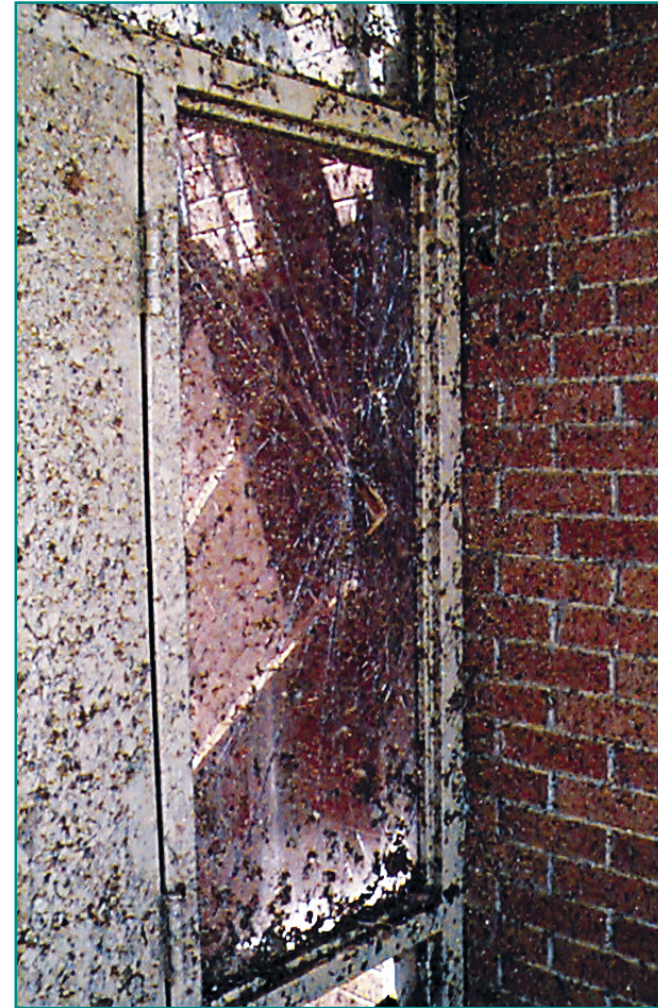
Figure 3-22
Impact performance of laminated glass. The corner of a table penetrated this laminated glass window, but the glass remained in its frame.

Damage was also caused by the impact of windborne missiles. Figure 2-3, in Chapter 2, shows a steel door that appeared to have been opened by the impact of a heavy object. This door led into an area where the roof was missing. The opening created by this breached door may have allowed wind to enter the building and create internal pressure that increased the load on the building envelope. Figure 3-22 shows damage to a laminated glass window hit by a table.

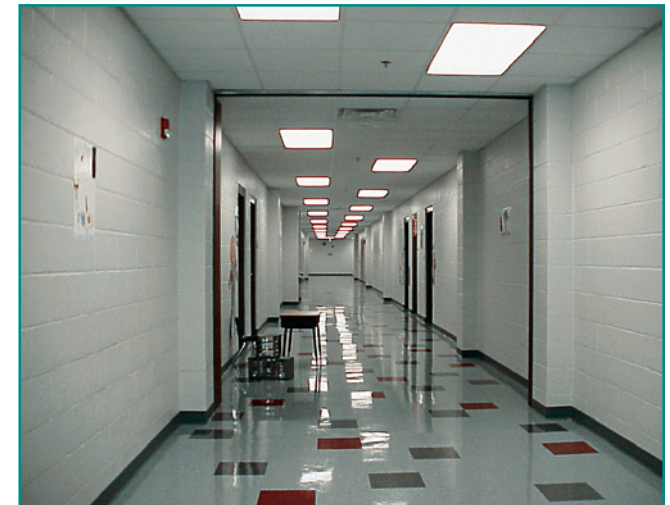
Figure 3-24
Corridor (designated safe area) in reconstructed Kelly Elementary School.

Because the damage to Kelly Elementary School was so great, the school was demolished and completely rebuilt. The new building, although constructed on the same footprint, incorporated several structural improvements specifically designed to provide improved resistance to extreme winds and create refuge areas for the school's occupants. As in the original building, the central corridors of the three wings are the designated refuge areas (Figures 3-23 and 3-24).

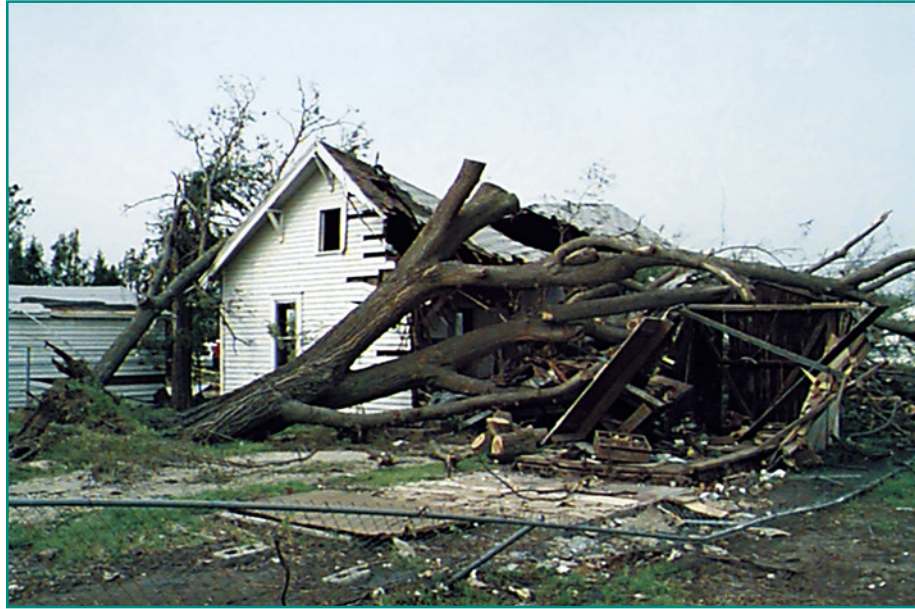
Two trees toppled by tornado winds damaged this house in Haysville, Kansas.

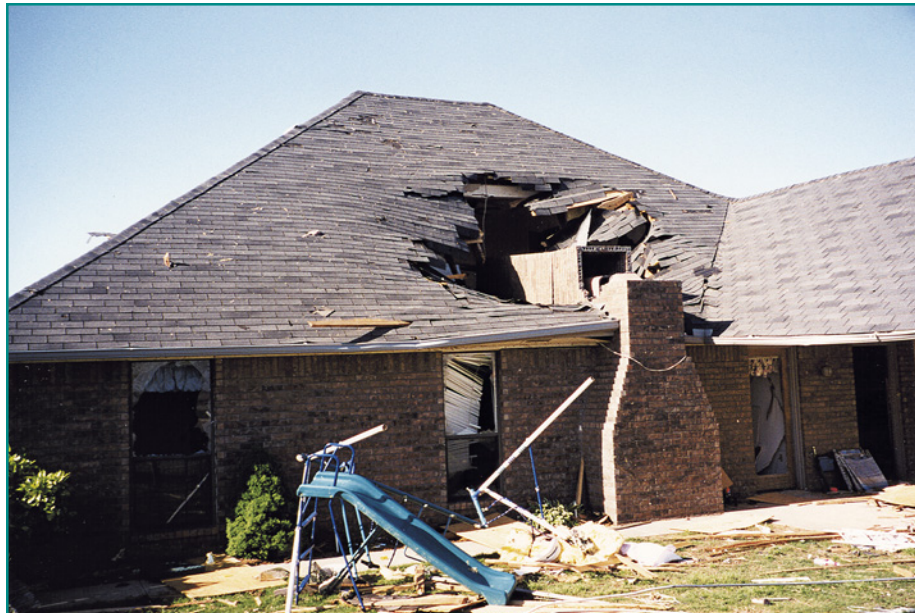
Failure of brick chimney under tornado winds damaged the room of this house in Moore, Oklahoma.

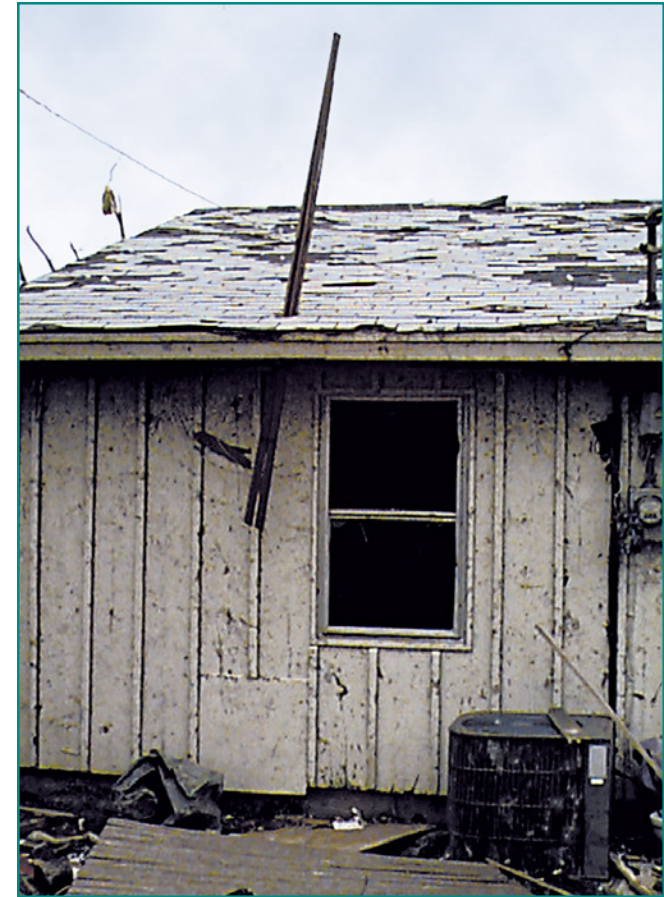
Figure 4-5

This photograph illustrates the importance of overhead protection in refuge areas. The missile shown here fell nearly straight down.
